Leziate & Ashwicken  
Highways Summary

July / August 2021

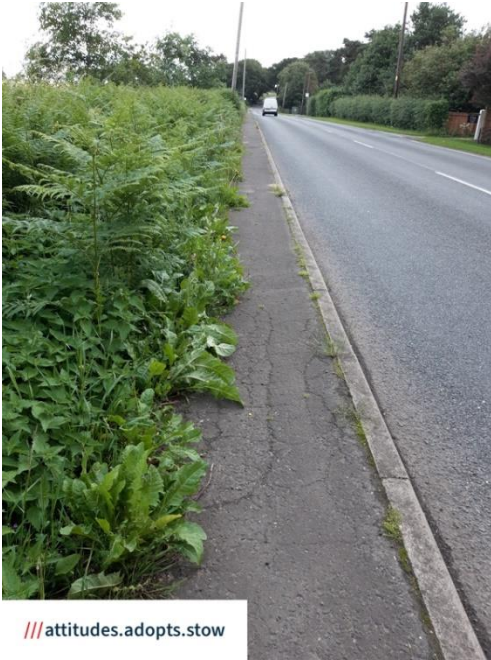
Ref	Location	Comment
B1145	Vegetation overgrowing footpath  EB lane Footpath opposite 10 Gayton Rd	w3w location ///attitudes.adopts.stow

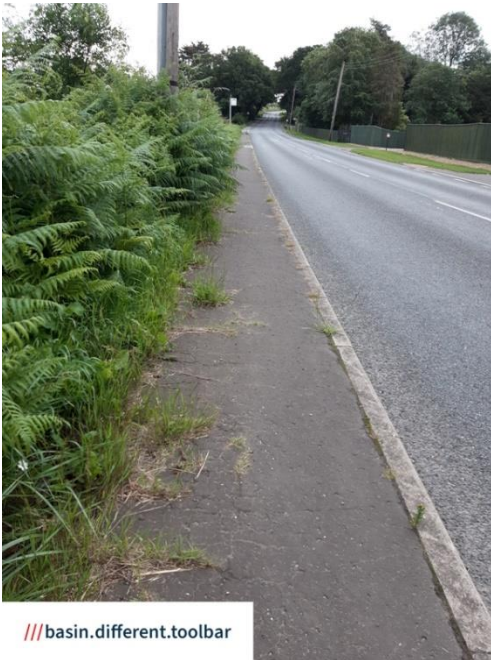
///attitudes.adopts.stow
B1145	Vegetation overgrowing footpath  EB lane Footpath opposite 14 Gayton Rd	w3w location ///basin.different.toolbar

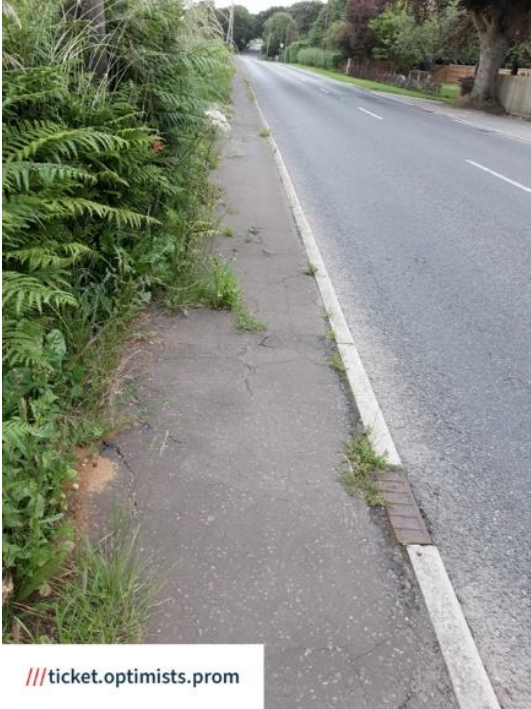
Ref	Location	Comment
B1145	Vegetation overgrowing footpath  EB lane Footpath opposite 6 Gayton Rd	w3w location ///ticket.optimists.prom

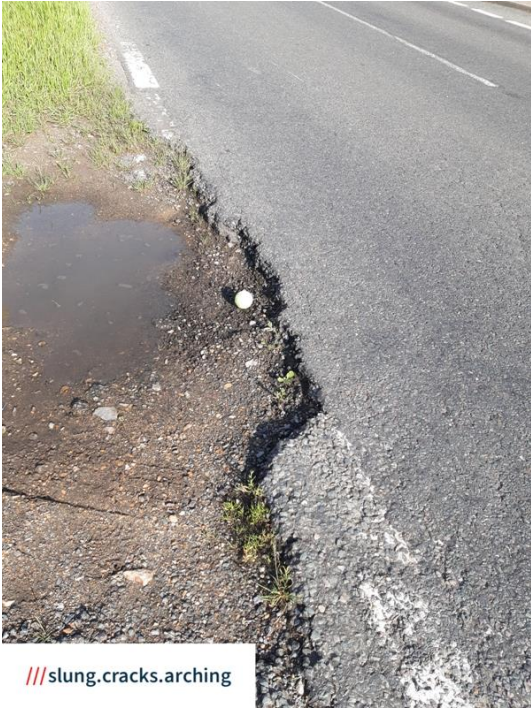
///ticket.optimists.prom
B1145	Loss of wearing course on edge of carriageway  EB lane opposite junction with Brow of The Hill	w3w location ///slung.cracks.arching

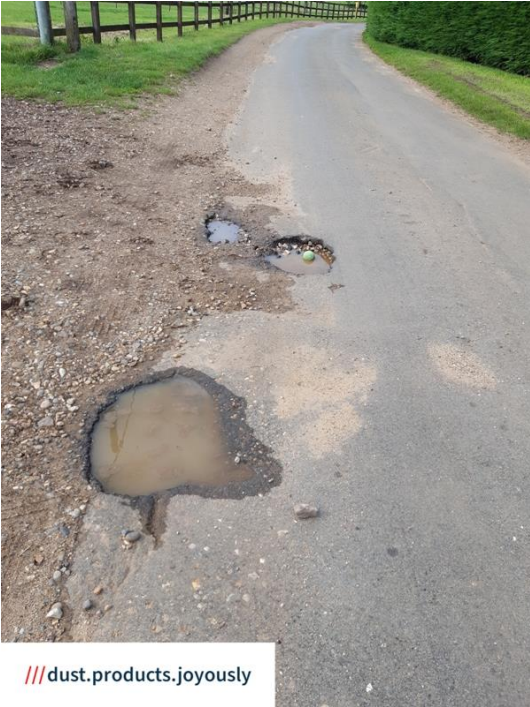
Ref	Location	Comment
Church Lane	Potholes in middle and edge of carriageway  entrance to Hadleigh Farm Stables	w3w location ///dust.products.joyously

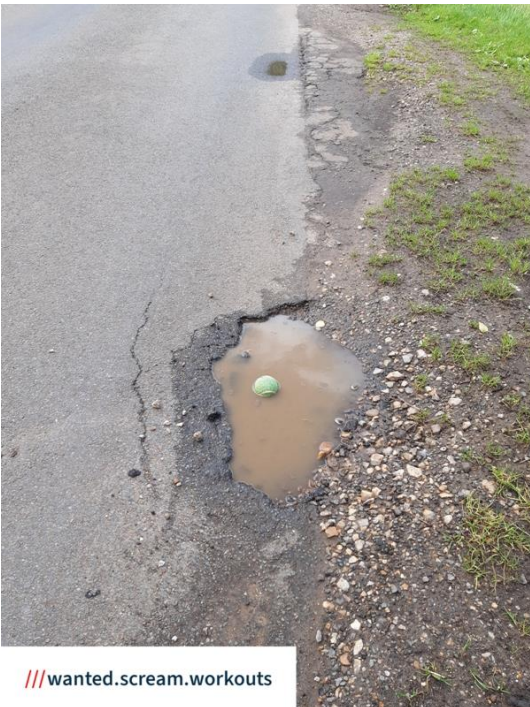
///dust.products.joyously
Church Lane	Potholes at edge of carriageway  opposite Nr 20	w3w location ///wanted.scream.workouts

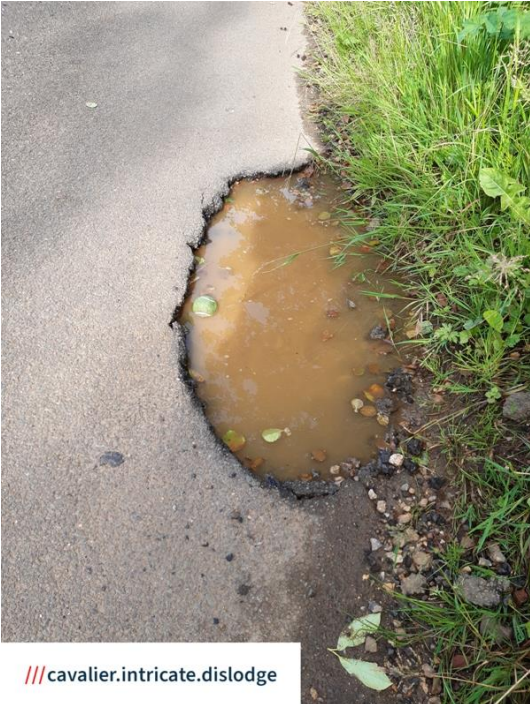
Ref	Location	Comment
Church Lane	<p>Potholes at edge of carriageway</p> <p>approx 15m east of solitary oak on the northern side of road</p>	<p>w3w location ///cavalier.intricate.dislodge</p>

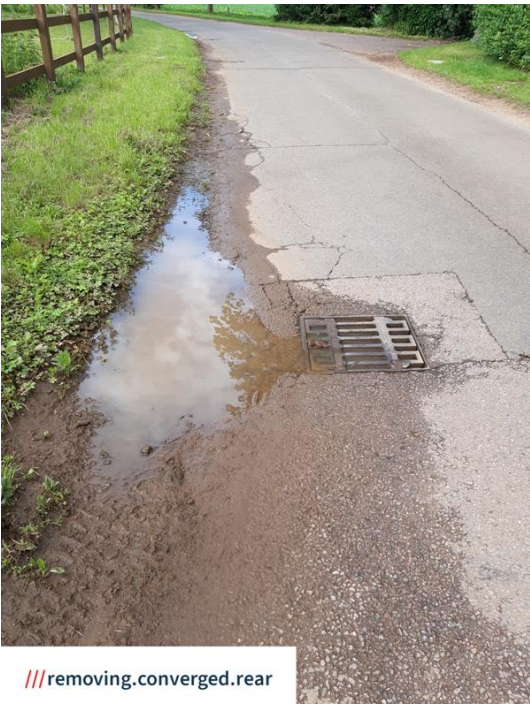
<p>///cavalier.intricate.dislodge</p>
Church Lane	<p>Potholes at edge of carriageway and clear signs that road gully and its discharge pipe are blocked.</p> <p>Surfacing cracking around gully</p> <p>approx 30m SE of entrance to Ashwicken Hall</p>	<p>w3w location ///removing.converged.rear</p>

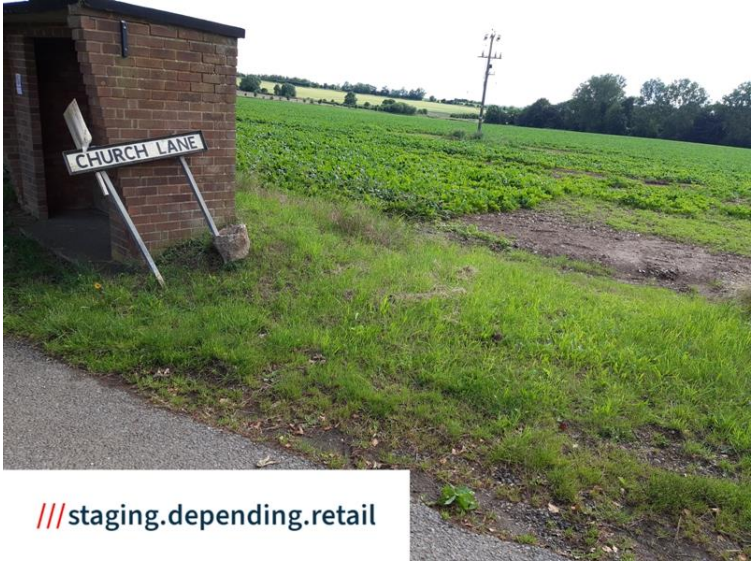
Ref	Location	Comment
Church Lane	<p>The Road sign for Church lane was damaged many months ago (and reported to NCC) by a vehicle that left the carriageway through the space visible in the photo. The sign and its posts are leaning against the adjacent bus shelter.</p> <p>at Junction with B1145</p>	<p>w3w location ///staging.depending.retail</p>

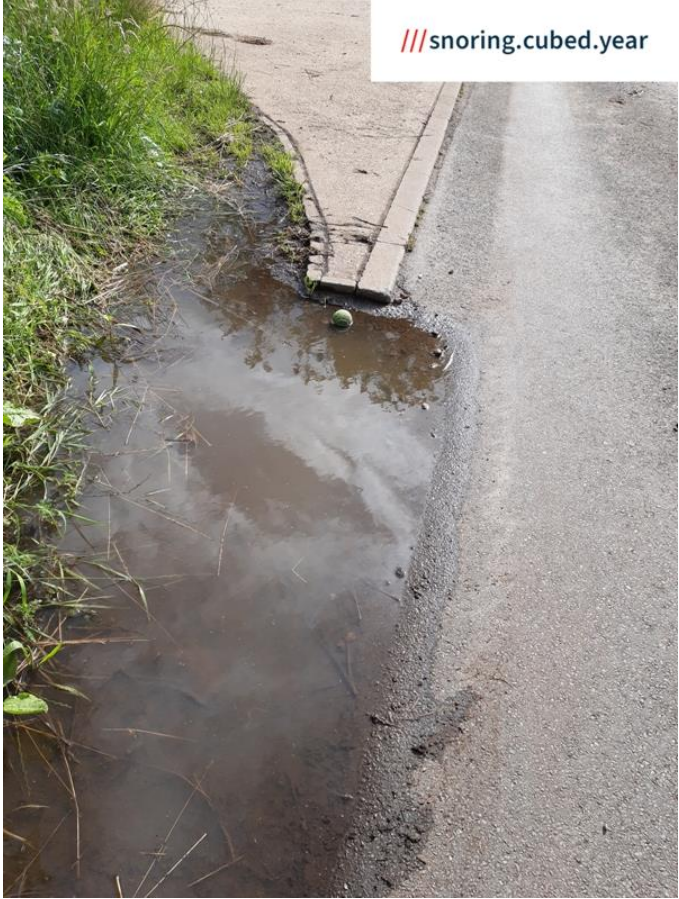
<p>///staging.depending.retail</p>
Church Lane	<p>Potholes at edge of carriageway adjacent to concrete paved bellmouth entrance to Sewage Treatment Plant leaving an abrupt step on the edge of the carriageway</p> <p>east side of entrance to Sewage Treatment Plant</p>	<p>w3w location ///snoring.cubed.year</p>

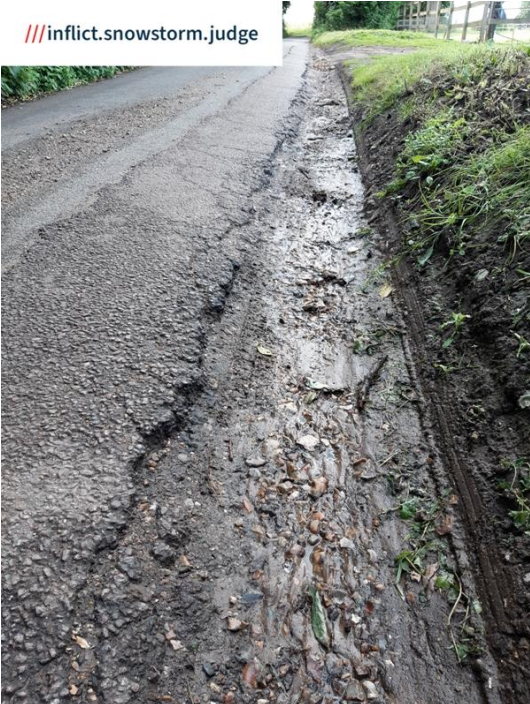
Ref	Location	Comment
Church Lane	<p>Failure of a significant length of the edge of Church Lane carriageway arising from passage of HGV and agricultural vehicles that are too wide to negotiate the road without damaging verge, permitting drainage water to affect the underlying pavement structure and breakup of the surfacing above</p> <p>East side near to field access, approx 60m south of postbox next to Old Rectory entrance</p>	<p>w3w location <a href="https://inflict.snowstorm.judge">///inflict.snowstorm.judge</a></p>

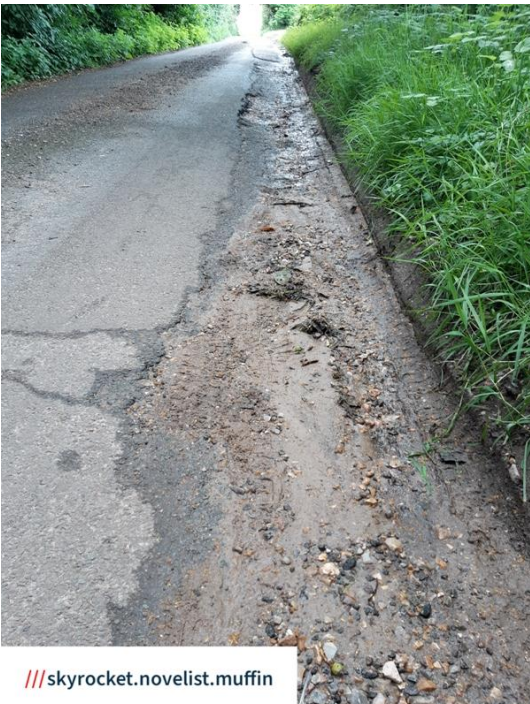
Church Lane	<p>Failure of a significant length of the edge of Church Lane carriageway arising from passage of HGV and agricultural vehicles that are too wide to negotiate the road without damaging verge, permitting drainage water to affect the underlying pavement structure and breakup of the surfacing above</p> <p>East side near to field access, approx 75m south of postbox next to Old Rectory entrance</p>	<p>w3w location <a href="https://skyrocket.novelist.muffin">///skyrocket.novelist.muffin</a></p>

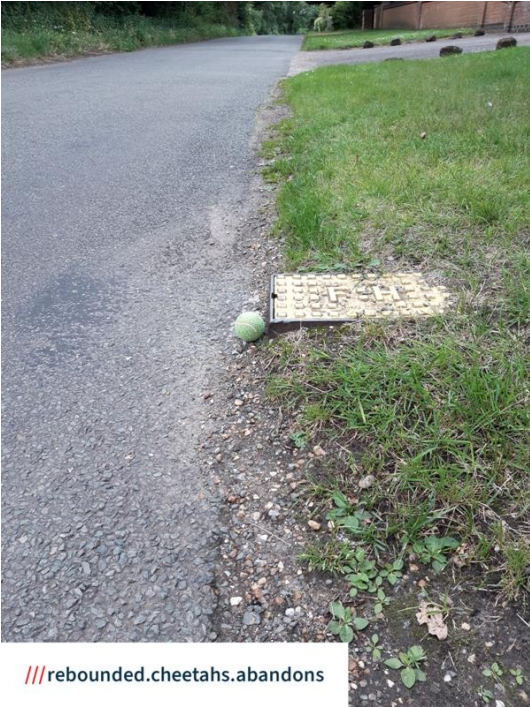
Ref	Location	Comment
Church Lane	<p>Raised iron works (fire hydrant valve cover) right on the edge of the carriageway</p> <p>next to Post Box outside Nr 53</p>	<p>w3w location ///rebounded.cheetahs.abandons</p>

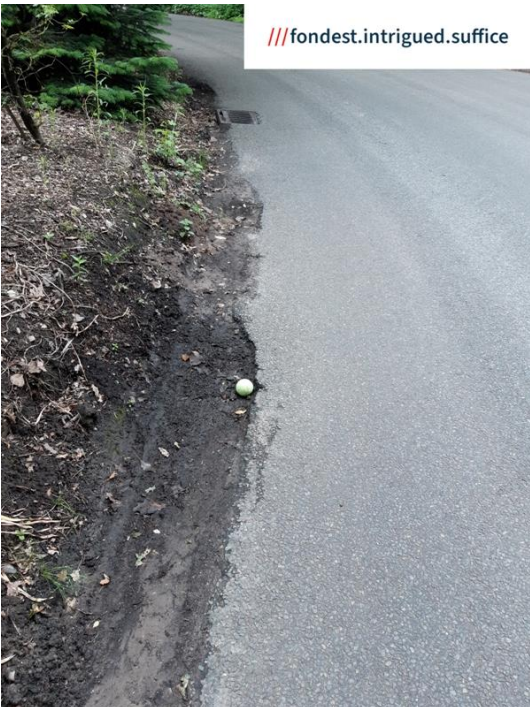
<p>///rebounded.cheetahs.abandons</p>
Church Lane	<p>Potholes at edge of carriageway</p> <p>opposite junction with Holt House Lane</p>	<p>w3w location ///fondest.intrigued.suffice</p>

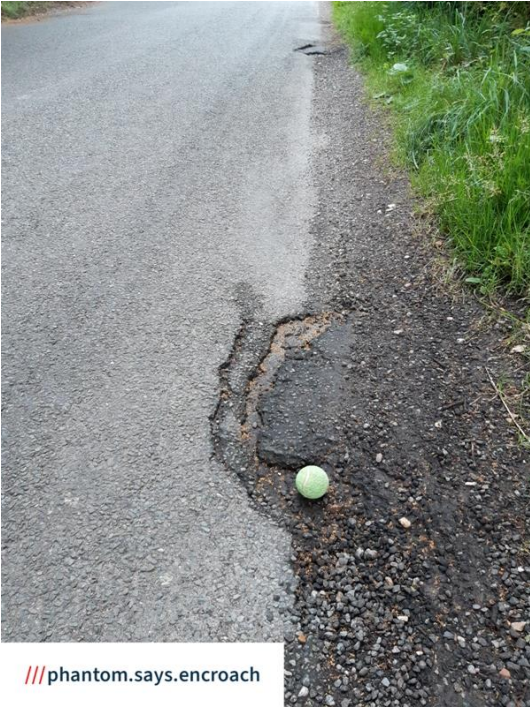
Ref	Location	Comment
Station Rd	Potholes at edge of carriageway outside Nr 17	<p>w3w location ///phantom.says.encroach</p>

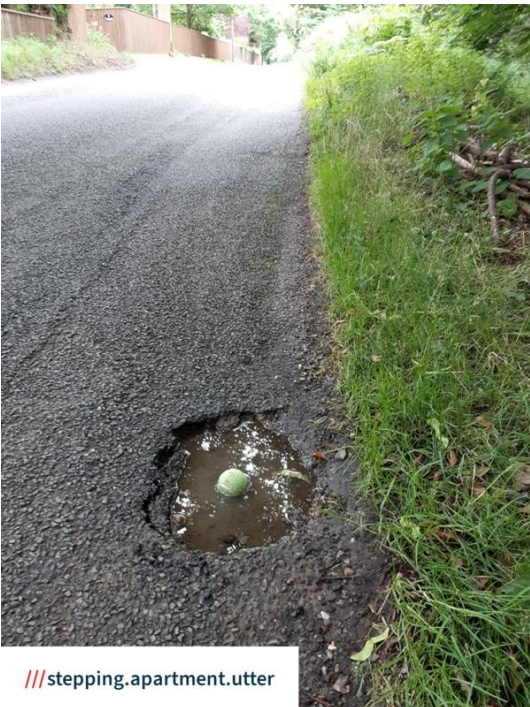
<p>///phantom.says.encroach</p>
Station Rd	Potholes at edge of carriageway outside Nr 19	<p>w3w location ///stepping.apartment.utter</p>

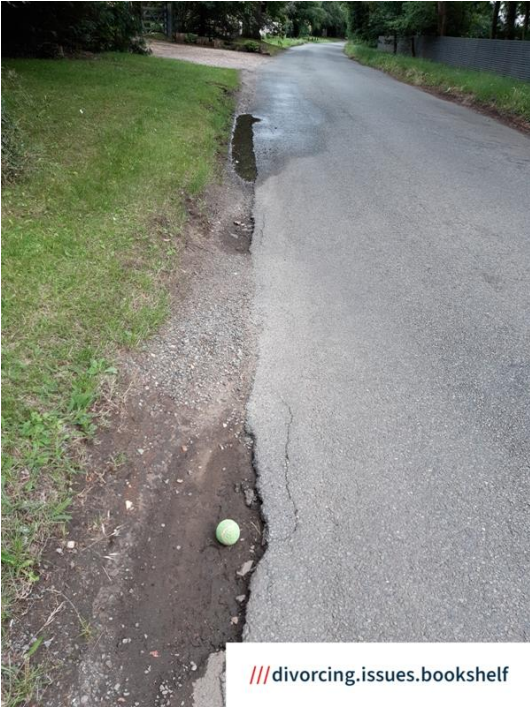
Ref	Location	Comment
<p>East Winch Rd</p>	<p>Potholes at edge of carriageway outside Nr 55 &amp; opposite Zenon House</p>	<p>w3w location ///divorcing.issues.bookshelf</p>

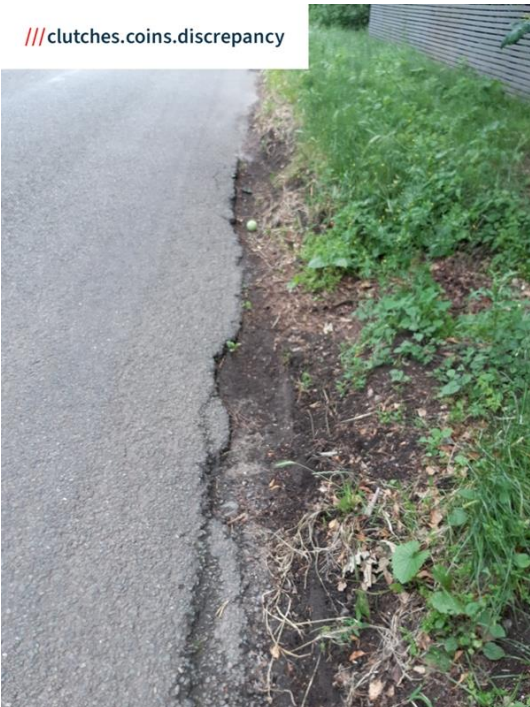
<p>///divorcing.issues.bookshelf</p>
<p>East Winch Rd</p>	<p>Potholes at edge of carriageway outside Nr 57 &amp; opposite Zenon House</p>	<p>w3w location ///clutches.coins.discrepancy</p>

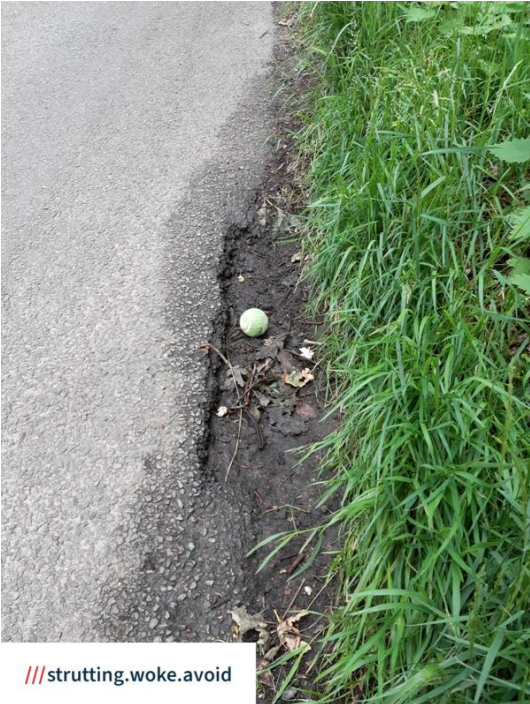
Ref	Location	Comment
<p>East Winch Rd</p>	<p>Potholes at edge of carriageway outside Nr 65</p>	<p>w3w location ///strutting.woke.avoid</p>

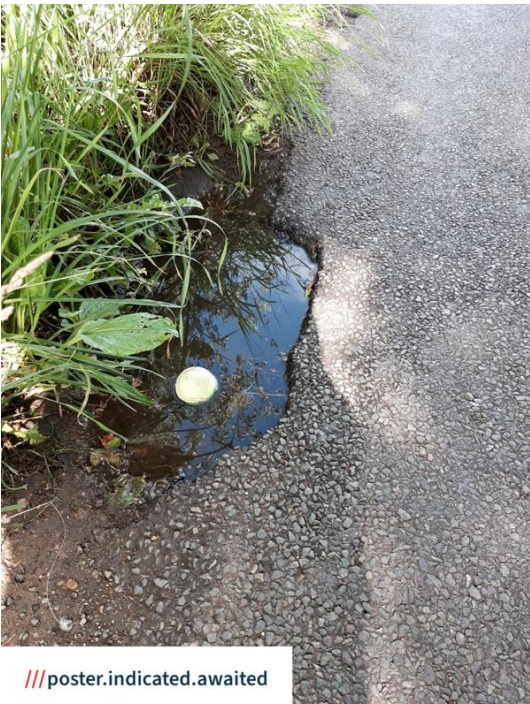
<p>///strutting.woke.avoid</p>
<p>East Winch Rd</p>	<p>Potholes at edge of carriageway approx 15m west of junction with Church Lane</p>	<p>w3w location ///poster.indicated.awaited</p>

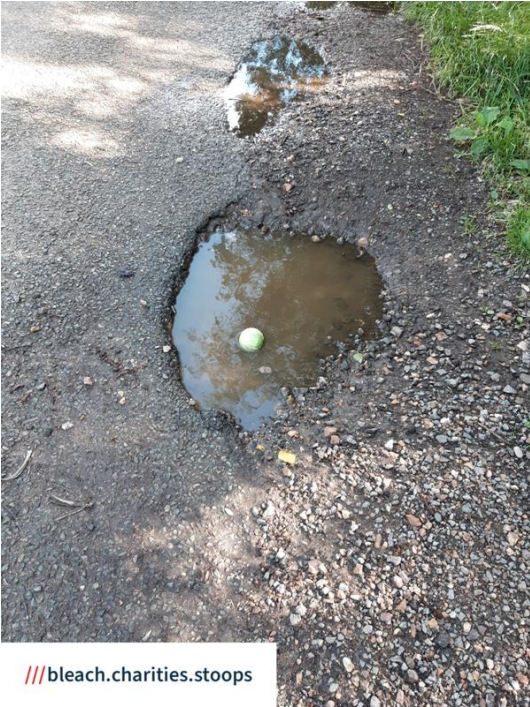
Ref	Location	Comment
East Winch Rd	Potholes at edge of carriageway  approx 200m south of junction with Church Lane	w3w location ///bleach.charities.stoops

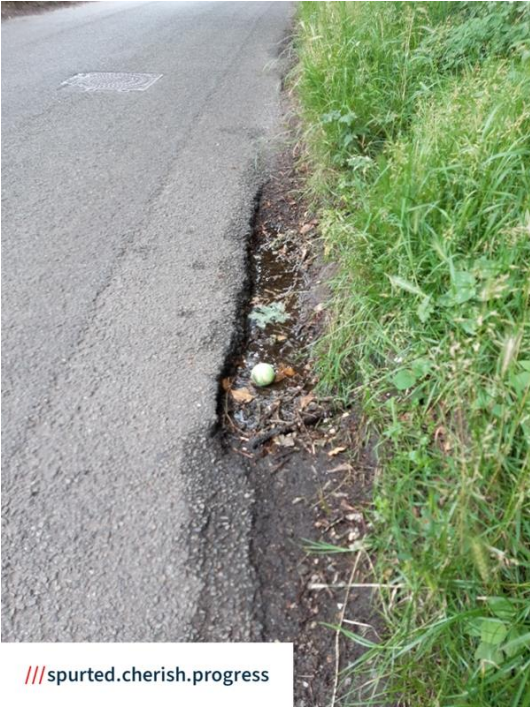
Ref	Location	Comment
East Winch Rd	<p>Potholes at edge of carriageway</p> <p>opposite junction with Leziate FP 19 emerging between Nr 67 and Nr 69 (1)</p>	<p>w3w location <a href="https://www.spurtd.cherish.progress">///spurtd.cherish.progress</a></p>

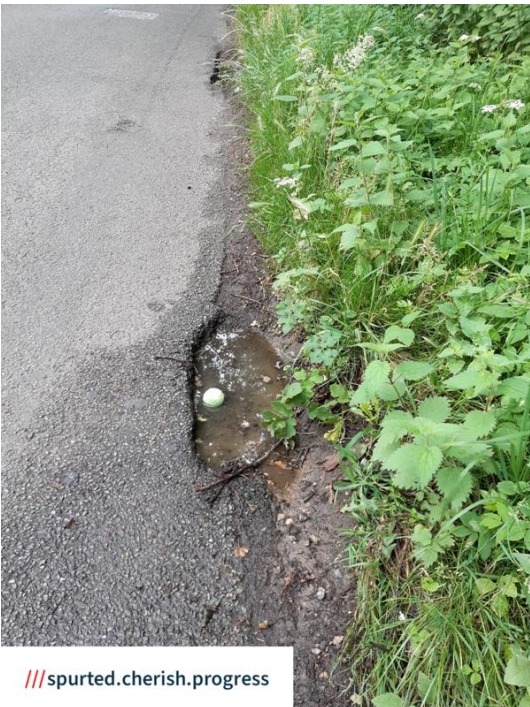
<p><a href="https://www.spurtd.cherish.progress">///spurtd.cherish.progress</a></p>
East Winch Rd	<p>Potholes at edge of carriageway</p> <p>opposite junction with Leziate FP 19 emerging between Nr 67 and Nr 69 (2)</p>	<p>w3w location <a href="https://www.spurtd.cherish.progress">///spurtd.cherish.progress</a></p>

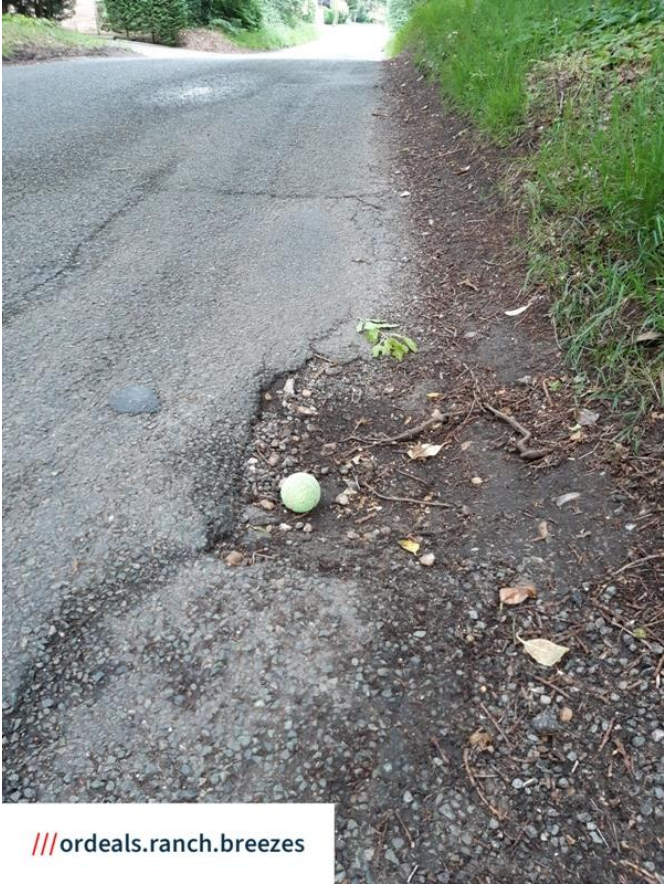
Ref	Location	Comment
<p>East Winch Rd</p>	<p>Potholes at edge of carriageway outside 39 Grey Cobbles</p>	<p>w3w location ///ordeals.ranch.breezes</p>

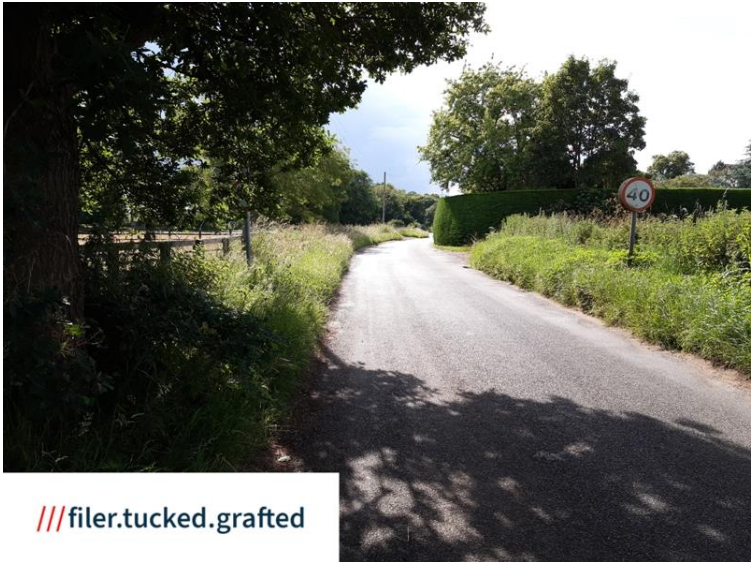
<p>///ordeals.ranch.breezes</p>
<p>East Winch Rd</p>	<p>Vegetation obscuring nearside speed restriction sign at a change from 60mph to 40mph WB Verge - approx 25m west of junction with Church Lane</p>	<p>w3w location ///filer.tucked.grafted</p>

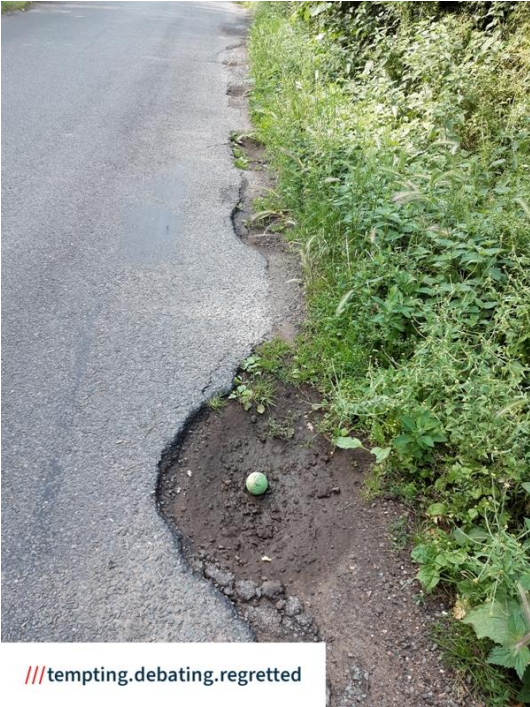
Ref	Location	Comment
<p>East Winch Rd</p>	<p>Potholes at edge of carriageway approx 260m north of entrance to The Deeds</p>	<p>w3w location ///tempting.debating.regretted</p>

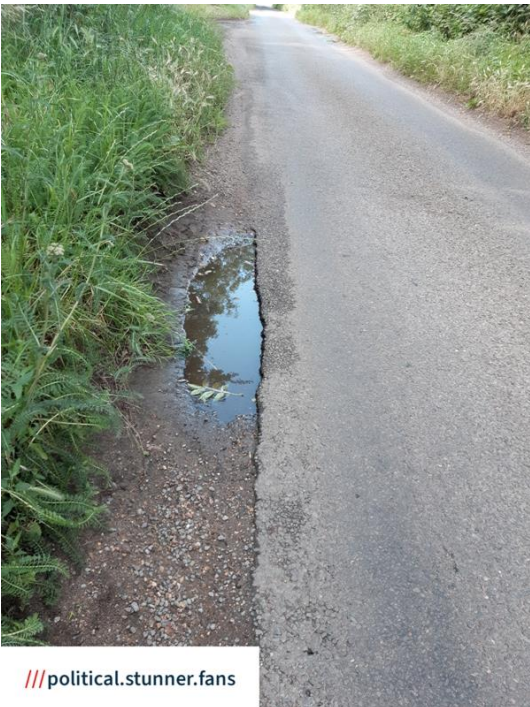
<p>///tempting.debating.regretted</p>
<p>East Winch Rd</p>	<p>Potholes at edge of carriageway approx 50m north of entrance to The Deeds</p>	<p>w3w location ///political.stunner.fans</p>

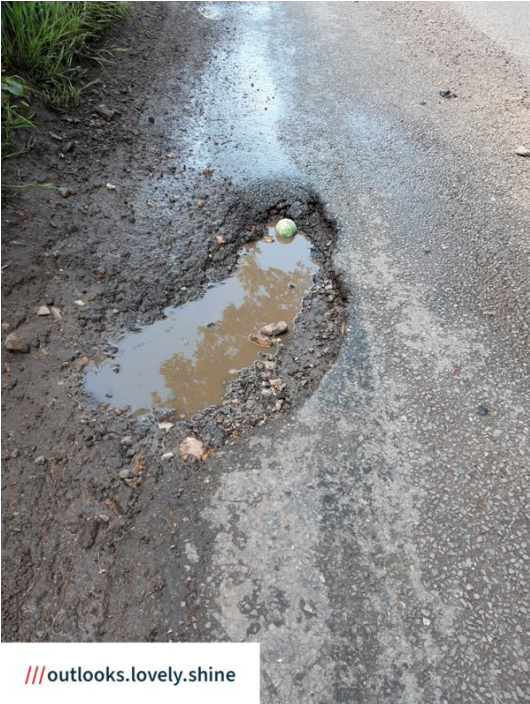
Ref	Location	Comment
East Winch Rd	Potholes at edge of carriageway  near to entrance of The Deeds	w3w location ///outlooks.lovely.shine

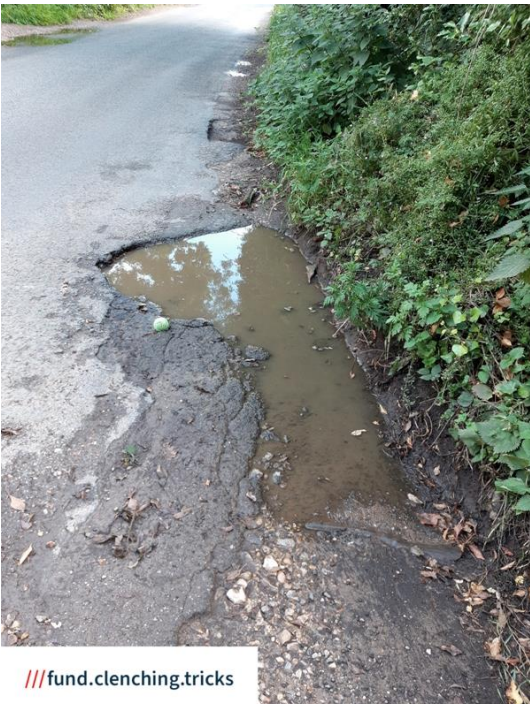
///outlooks.lovely.shine
East Winch Rd	Potholes at edge of carriageway  opposite Lilac Lodge	w3w location ///fund.clenching.tricks

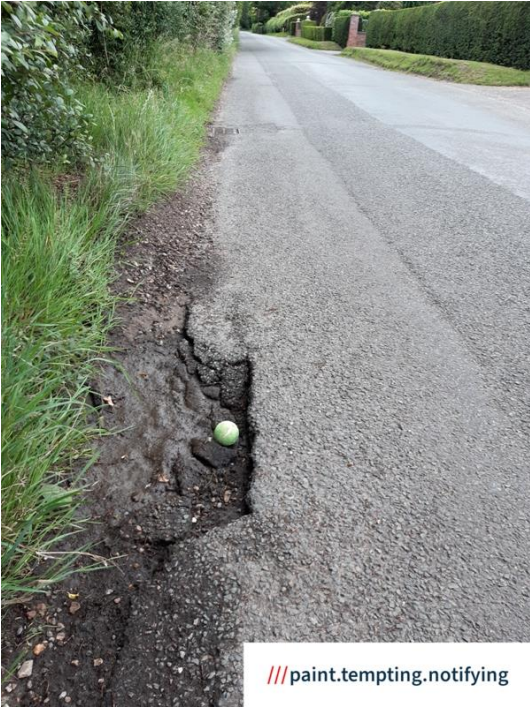
Ref	Location	Comment
<p>East Winch Rd</p>	<p>Potholes at edge of carriageway  opposite No 35</p>	<p>w3w location ///paint.tempting.notifying</p>

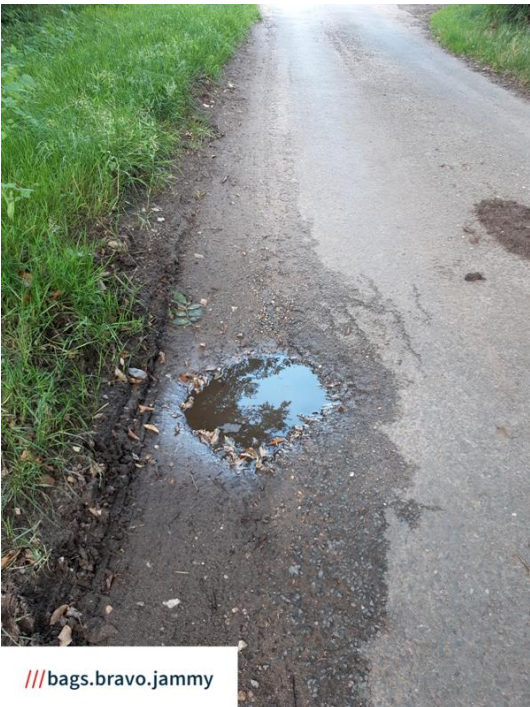
<p>///paint.tempting.notifying</p>
<p>Holt House Lane</p>	<p>Potholes at edge of carriageway  between 10 and 15 Holt House Lane</p>	<p>w3w location ///bags.bravo.jammy</p>

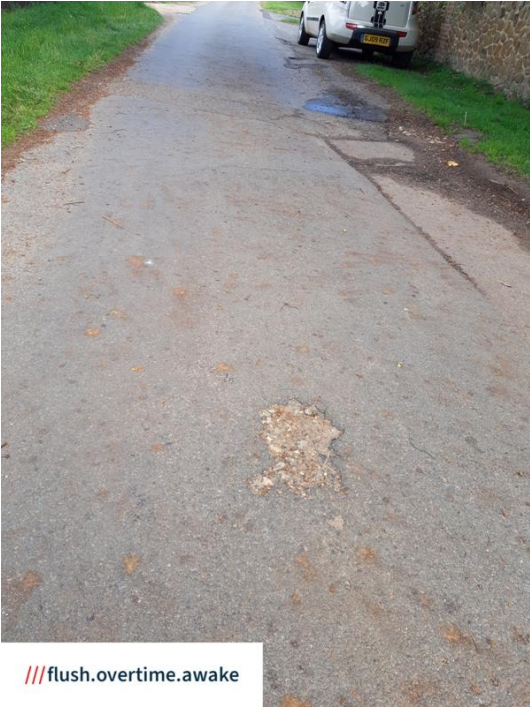
Ref	Location	Comment
Holt House Lane	<p>Potholes in middle of carriageway</p> <p>between 4 Holt House Lane and side of 15 Station Rd</p>	<p>w3w location ///flush.overtime.awake</p>

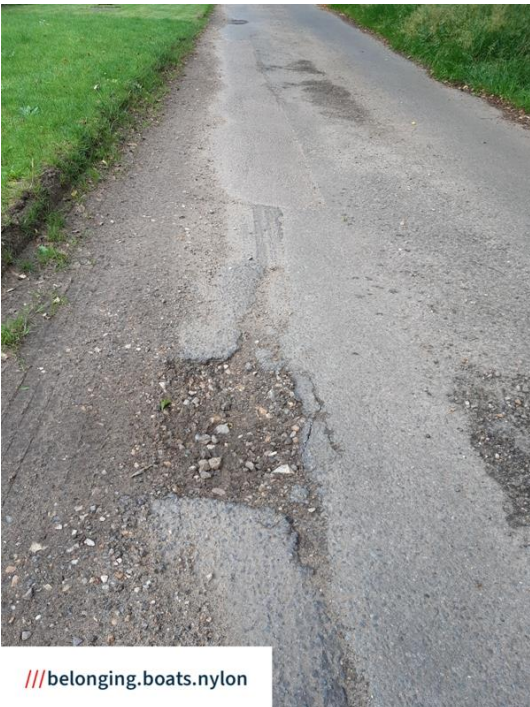
<p>///flush.overtime.awake</p>
Holt House Lane	<p>Potholes at edge of carriageway</p> <p>opposite 11 Holt House Lane</p>	<p>w3w location ///belonging.boats.nylon</p>

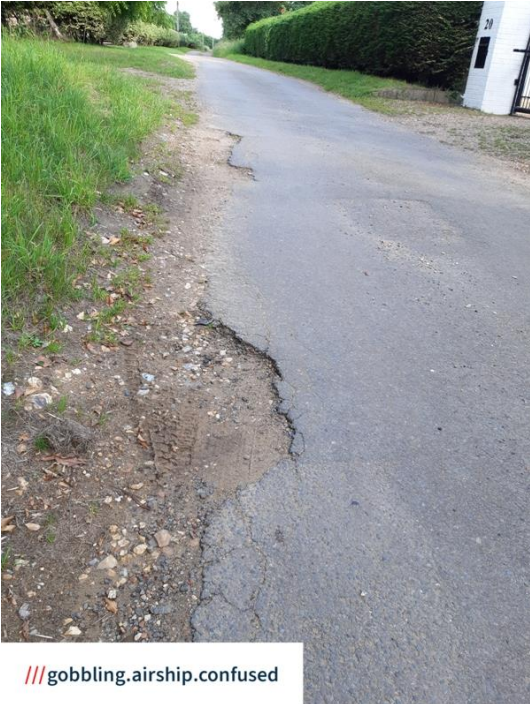
Ref	Location	Comment
Holt House Lane	<p>Potholes at edge of carriageway</p> <p>outside 20 Holt House Lane</p>	<p>w3w location ///gobbling.airship.confused</p>

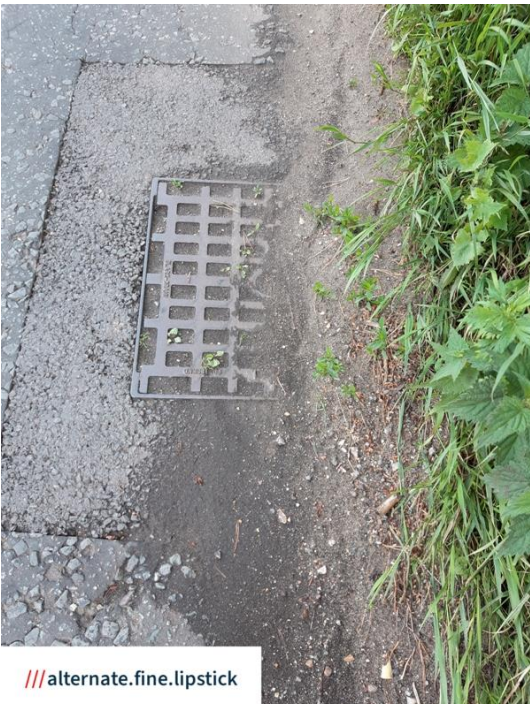
<p>///gobbling.airship.confused</p>
Leziate Drove	<p>Blocked gully and its outfall pipe</p> <p>NB Nearside Lane next to entrance track to Pightle Farm</p>	<p>w3w location ///alternate.fine.lipstick</p>

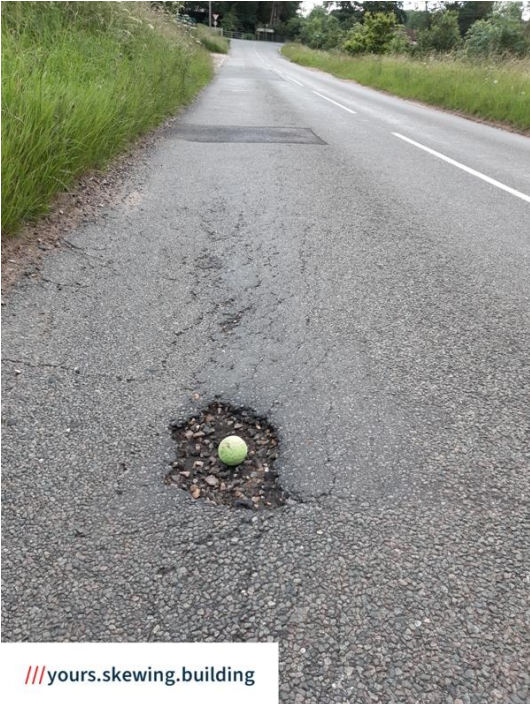
Ref	Location	Comment
Leziate Drove	<p>Potholes at edge of carriageway</p> <p>SB lane 30m N of driveway to 215 Leziate Drove</p>	<p>w3w location ///yours.skewing.building</p>

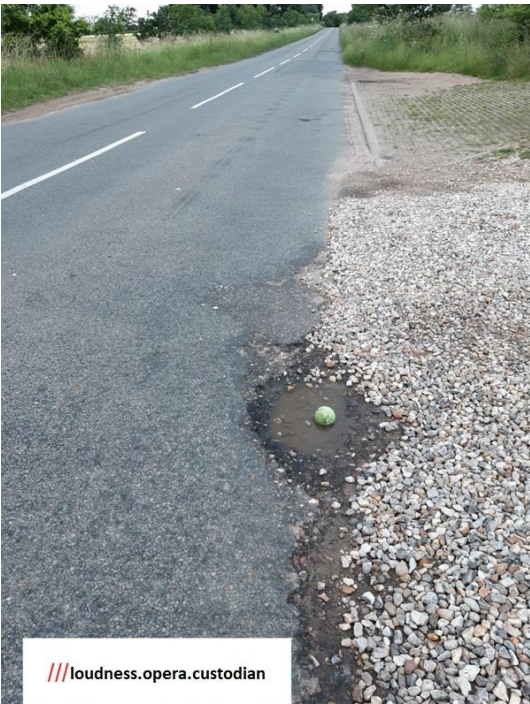
Leziate Drove	<p>Potholes at edge of carriageway</p> <p>SB lane driveway to 215 Leziate Drove</p>	<p>w3w location ///loudness.opera.custodian</p>
